PRELIMINARY REPORT OF FOREST PROTECTION REQUIREMENTS

ORGAN PIPE CACTUS NATIONAL MONUMENT

Regional Forester V. W. Saari

Santa Fe, New Mexico
October, 1941

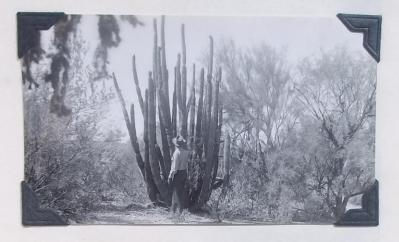
Organ Pipe Cactus, Mesquite, Palo Verde, Ironwood

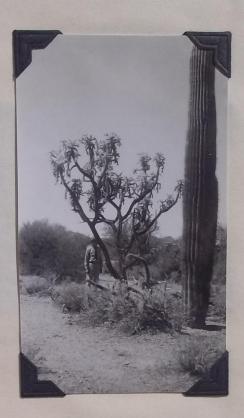
Typical Cholla Stand

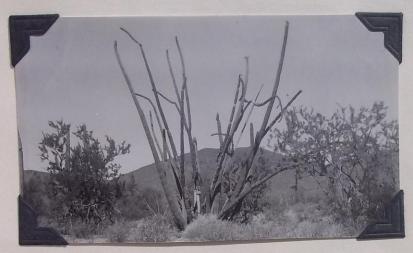
In general, the Organ Pipe cactus seems to be less healthy than the Saguaro cactus. It is affected with a disease similar to the

condition found in the Saguaro. Recently killed stems and dead plants were conspicuous in all the Organ Pipe stands observed.

Diseased Organ Pipe Cactus

The Senita cacti observed showed a diseased condition in their oldest stems. The younger stems did not appear to be infected and no entire plants or groups of plants were found to be killed. In view of the serious epidemic conditions prevailing in the Saguaro stands at Saguaro National Monument, careful observations should be maintained of the cactus stands within this monument to prevent any epidemics of the nature now occurring at Saguaro becoming started at Organ Pipe.

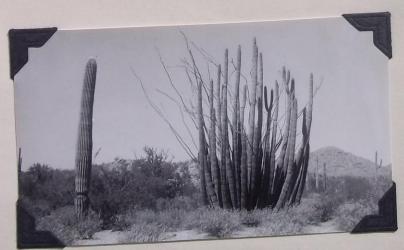
Non-infected Organ Pipe Cactus
